STANDEL SERVICE INFORMATION

1968

ACOUSTIC MAGNIFIERS AND PA COLUMN AMPLIFIERS
PB50, PB100, AM48, AM48S, AM30, AM30S
AM24, AM24S

CROSS-OVER CORRECTION FOR ALL 1968 ACOUSTIC MAGNIFIERS

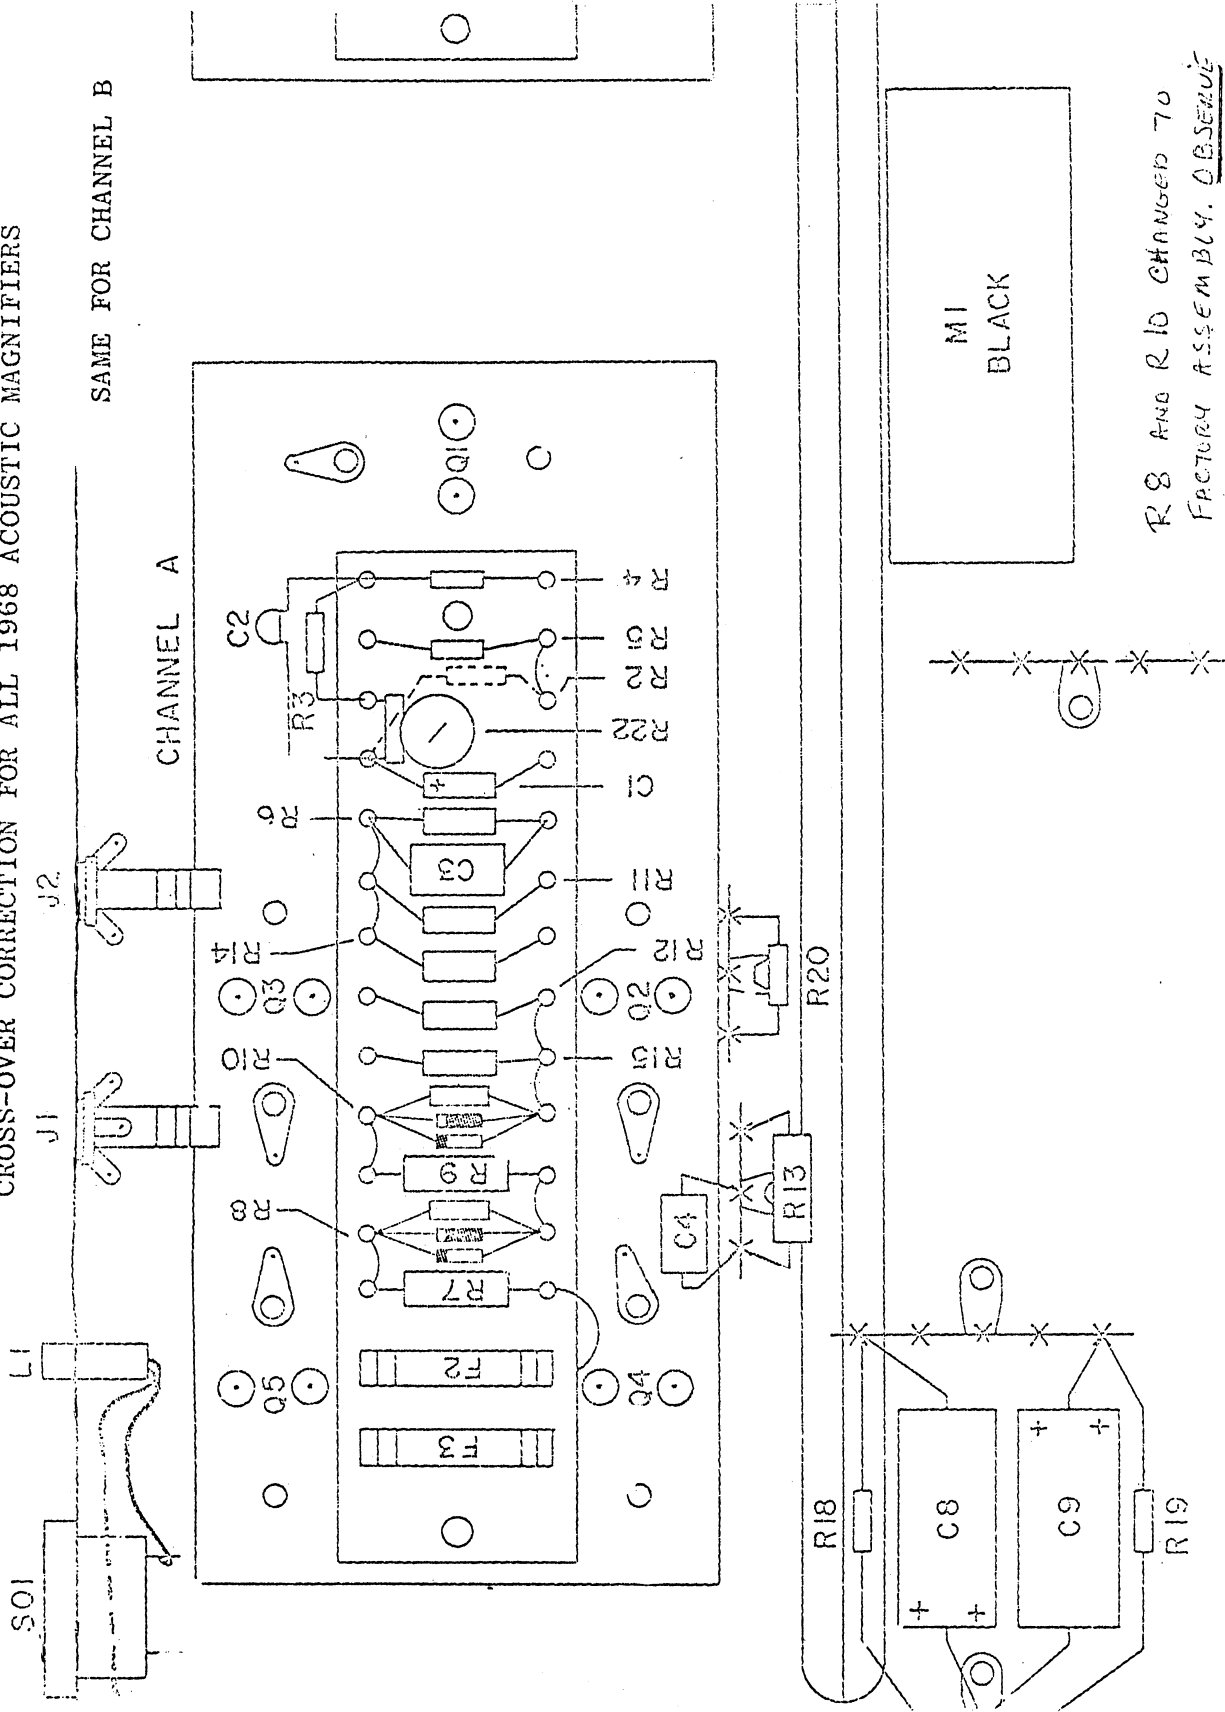
SAME FOR CHANNEL B

R8 AND R10 CHANGED TO
FACTORY ASSEMBLY. OBSERVE
POLARITY
R7 AND R9 CHANGED TO
2.7K 1W 5%

In some cases under low power line voltage conditions, the amplifier will develop low level distortion which sounds very much like a bad speaker.

The problem will generally occur at line voltages below 115V when the amplifier is played at low volume levels.

This can be eliminated by replacing resistors R7, R8, R9, and R10 as shown on the schematic diagram. Replacement kit must be obtained from the Standel Company. When ordering replacement kit, please send the model and serial number of the amplifier involved.

If it is necessary to replace the power drive transistor or related components, it will be necessary to re-adjust R22 as indicated on schematic. Should it be necessary to replace the power transistors, matched sets should be obtained from the factory and silicon grease should be used between the transistor and heat sink to provide maximum heat transfer. Care should be taken to position the teflon insulating spacers correctly to avoid shorting the transistors to the chassis.

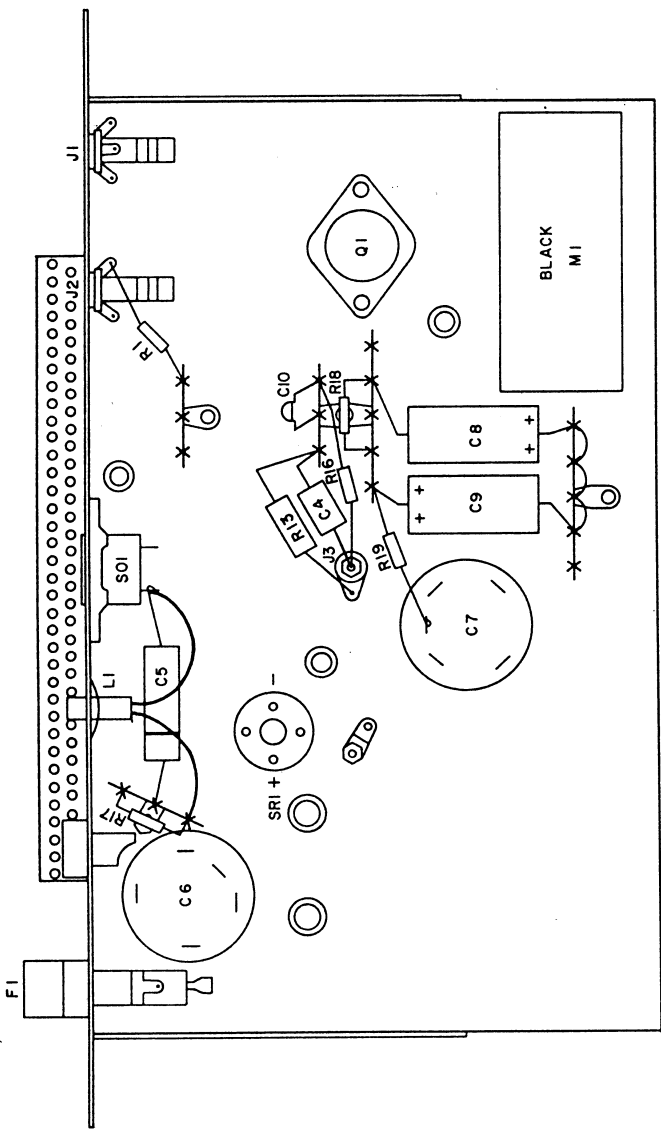
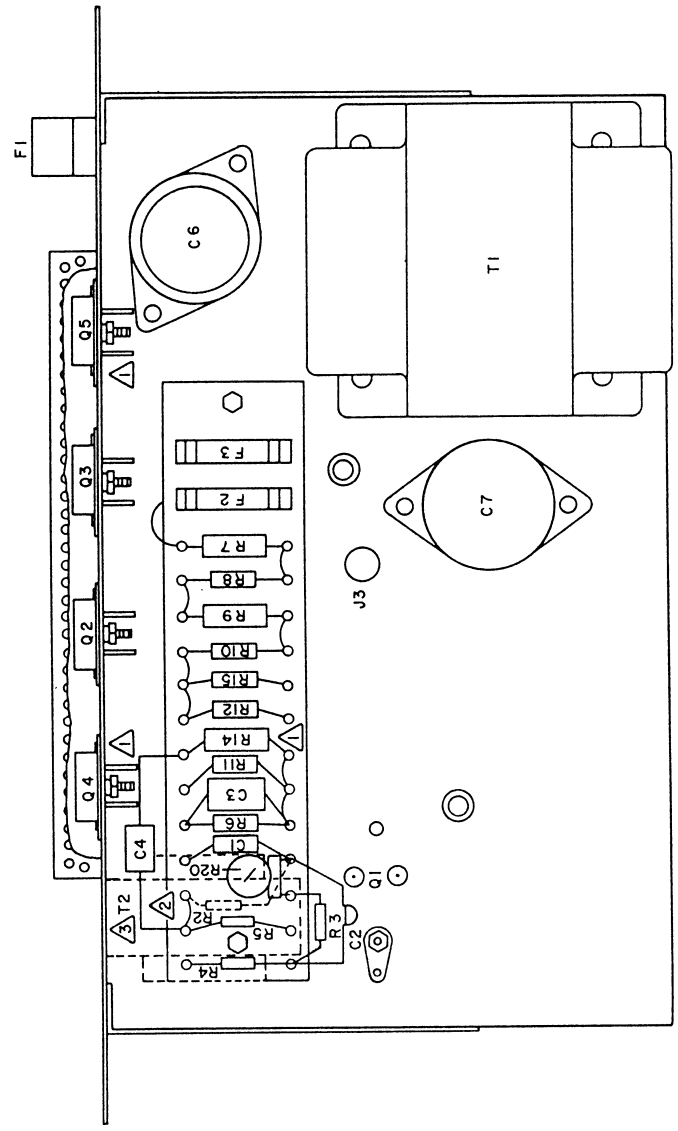
PICTORIAL DIAGRAM
1968
PB 50 AND PB 100

- ⚠ Q4, Q5, R14 AND R15 NOT USED IN PB50.
- ⚠ R2 LOCATED BELOW BOARD .
- ⚠ T2 DASHED TO SHOW PARTS BELOW .
